Site Certification for the Williamsburg Cooperative Commerce Centre South In Williamsburg County, South Carolina

Attachment 21

Wetlands Delineation for Epps No. 1 Industrial Site

Wetlands Delineation for Tracts 8-10 and 13 of the Williamsburg Cooperative Commerce Centre U.S. Army Corps of Engineers - Charleston District - Regulatory Division

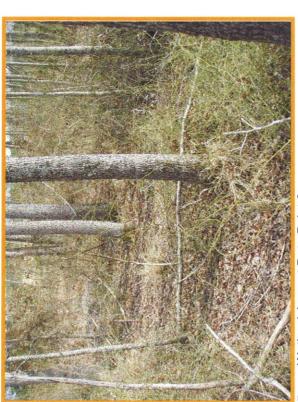
Wetland Area at Data Point 2. S

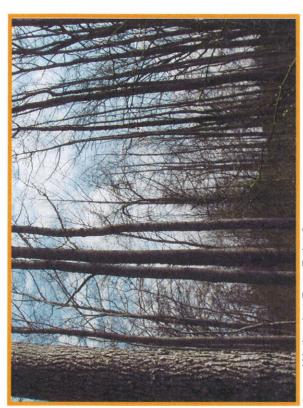
Wetland at Data Point 2. 9

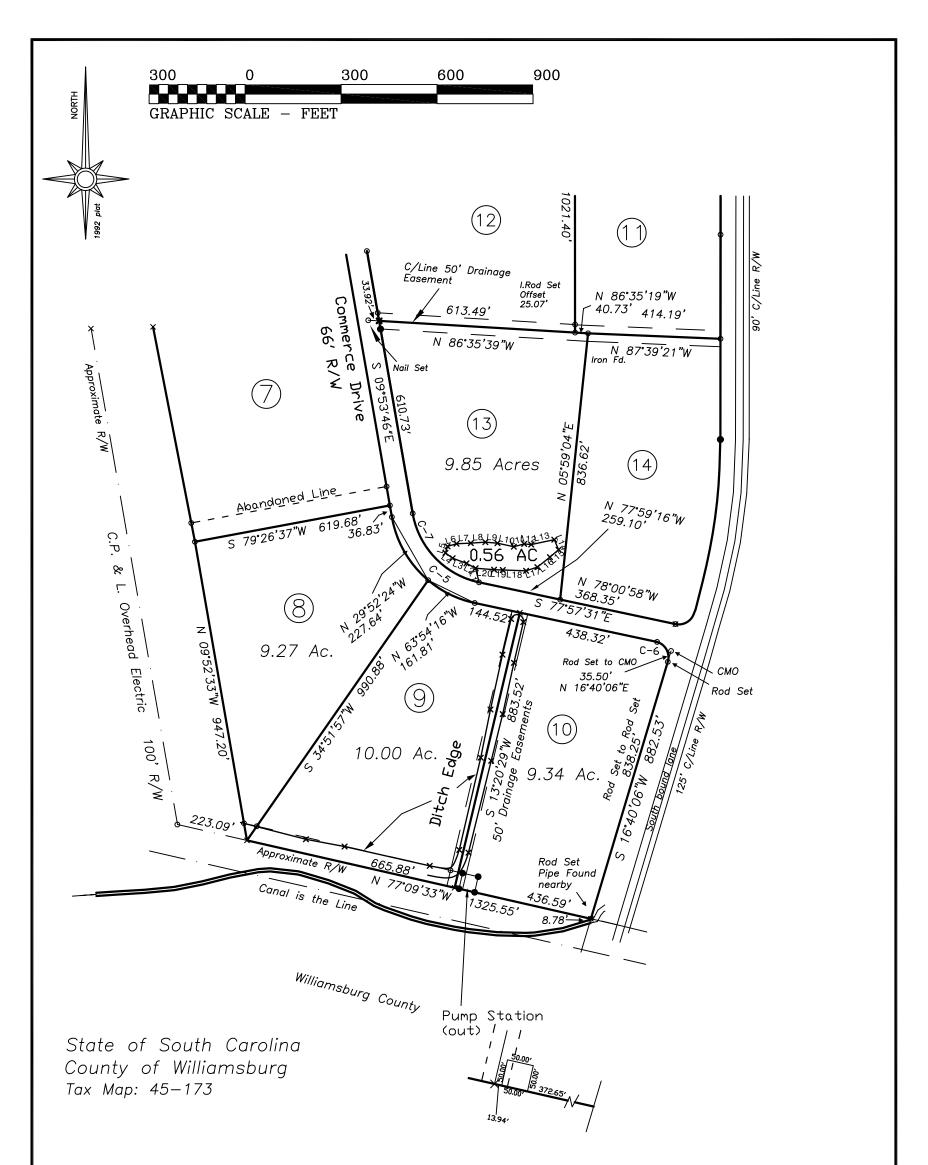
CURVE RADIUS	TANGENT	LENGTH	DELTA	DEGREE	CHORD	CH.BEARING			
	C—5 333.15' C—6 50.00' C—7 267.15'	224.98' 50.00' 180.41'	395.76' 78.54' 317.36'	68°03'45" 90°00'00" 68°03'45"	17•11'53" 114•35'30" 21•26'48"	372.90' 70.71' 299.02'	S 43*55'39"E S 28*19'54"E N 43*55'39"W			
								Course	Bearing	Distance
I									N 13°52'14" W	45.50
I									N 62°11'16" W	32.23
I									N 69°24'04" W	46.12
						· ,		L4	N 53°34'22" W	28.01
I	Williamsburg County							L5 L6	<u>N 17°43'13" E</u>	21.14
I									N 73°41'16" E	29.33
I									<u>N 87°26'09" E</u>	44.72
I	J.B. Ellis, Jr	Development Corporation						L8	<u>N 86°11'46" E</u>	45.69
I	LLS 13849							L9 L10	<u>S 85°04'56" E</u> S 77°59'05" E	37.71 52.49
I									<u> </u>	33.35
I	415 East Main Street							L11 L12	S 84°54'34" E	22.15
I	Kingstree, SC				L13	N 78°02'22" E	73.91			
I	0							L14	S 22°34 08 E	34.09
I	843-355-6872							L15	\$ 49°25'12" W	35.48
I		Wetlan	Wetland Survey of Lots 8, 9, 10 and 13						S 51°26'52" W	50.22

I		-						L17 L18	S 71°53'32" W	37.00
I		S	Survey Completed: April 28, 2011						<u>N 88°00'49" W</u>	72.92
I	WBUG2101 wetMoy 1998	_							N 87°30'14" W	27.18
I									N 85°32'32" W	57.96
